MEMO

RE: December 1st, 2014 site walk through, December 17th, 2014 mercury vapor

survey at Tatooine Industries International, located at 4390 I-80 Service

Road, Burns, WY, Date: December 29th, 2014

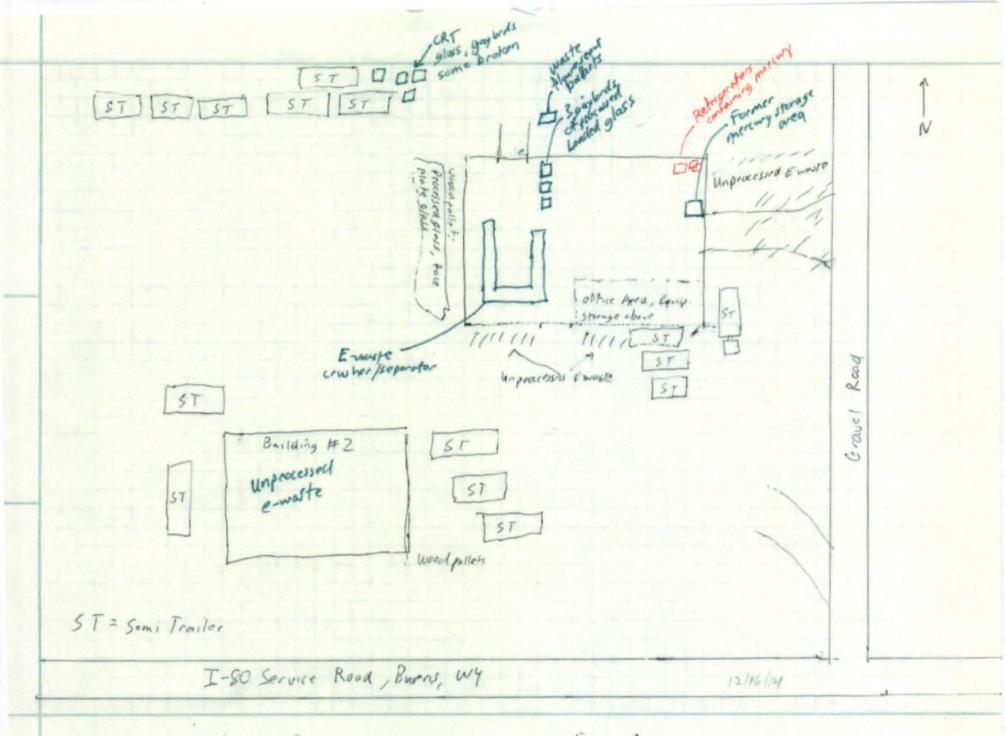
Figure 1 represents the outside site conditions as noted during the December 1st, 2014 inspection and December 16th, 2014 off-site observations.

North side – approximately 15 to 20 gaylords of broken CRT glass was located in and near the loading dock in the northwest corner. Each gaylord could not be completely examined and the possibility exists that these gaylords contain leaded glass. The condition of the gaylords was generally poor and there were several gaylords that were completely broken down (see 12/1/14 photos #63, #65, #66, #67). Three wooden boxes to the east of loading dock contained what appeared to be fluorescent light ballasts (see photo #69).

East side – This is the e-waste delivery dock. Large amounts of whole unprocessed computers, monitors/tvs, printers, aluminum airplane parts, wood pallets and various other waste electronics are located in this area (see 12/1/14 photos #43-#47). The e-waste is not covered and some are in gaylord containers and some of it is directly on the concrete pad. The condition of most of the gaylords appeared to be poor. On the S-SW corner of the building there is an open top semi-trailer which reportedly contains aluminum parts from an aircraft.

South side – This side of the building has three parked semi-trailers on the southeast corner and gaylords containing e-waste and metal recyclables. The rest of the length of the south side, excepting the large bay entrance door, contains gaylords of unprocessed e-waste and several small bins containing separated metal recyclables (see 12/1/14 photos #48, #49).

West side – Approximately 100 complete and broken gaylords of broken CRT glass in addition to a large number of wooden pallets (see 12/1/14 photos #50, #58, #59, #60, #61, #62, #63). Each gaylord could not be completely examined and the possibility exists that these gaylords contain leaded glass.

To the northwest of building 1 is a line of 6 semi-trailers containing e-waste. Previous inspections showed that these semi-trailers contained whole CRT monitors and televisions along with other e-waste (see 12/1/14 photos #50, #58, #59, #68). On the east end of these semi-trailers there were 4-5 gaylords of broken CRT glass. Each gaylord could not be completely examined and the possibility exists that these gaylords contain leaded glass.

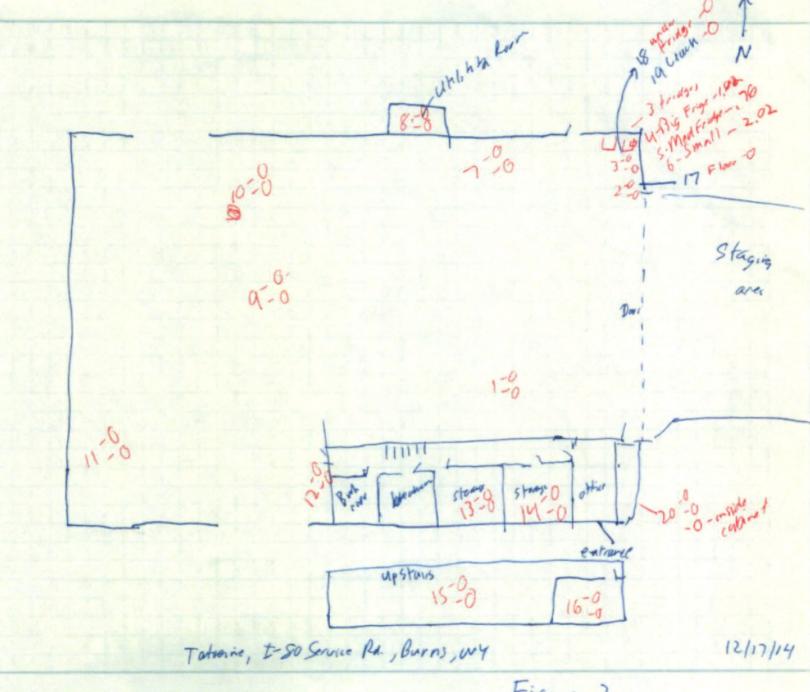
Figure 2

Ambient air was sampled for mercury vapor at floor level and eye level at 14 discreet locations, one sample was taken in each refrigerator storing mercury (3 total), and 3 samples were taken at floor level around the area where the mercury was stored (see 12/17/14 photos). A total of 34 discrete samples were taken. All sampling events registered 0.00 micrograms/cubic meter of mercury with the exception of the samples taken inside of the refrigerators as follows:

Sample 4	Large Refrigerator	1.02 micrograms/cubic meter
Sample 5	Medium Refrigerator	0.76 micrograms/cubic meter
Sample 6	Small Refrigerator	2.02 micrograms/cubic meter

All positive samples for mercury were below the OSHA PEL for mercury.

Tatooine Industries International 4390 I-80 Service Road, Burns, WY, Building #1 12/17/14 Mercury Vapor Survey Test Results Jerome J-405 Mercury Vapor Analyzer

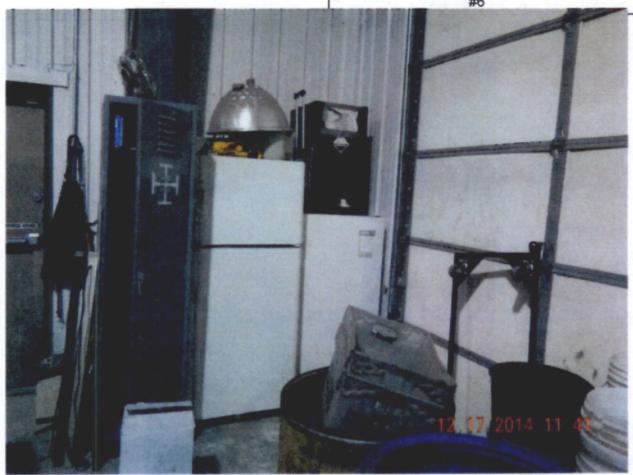
Mercury containing refrigerators, NE corner building #1, sample points #4, #5,

#6

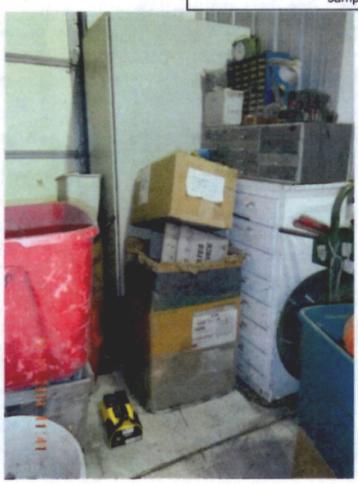
Area where mercury containing refrigerators were formerly located, NE corner building #1,

sample point #2A

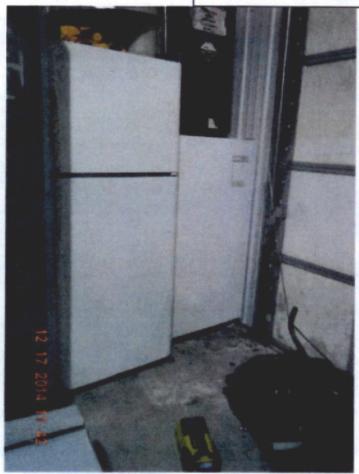
Mercury containing refrigerators, NE

corner building #1, sample point #18

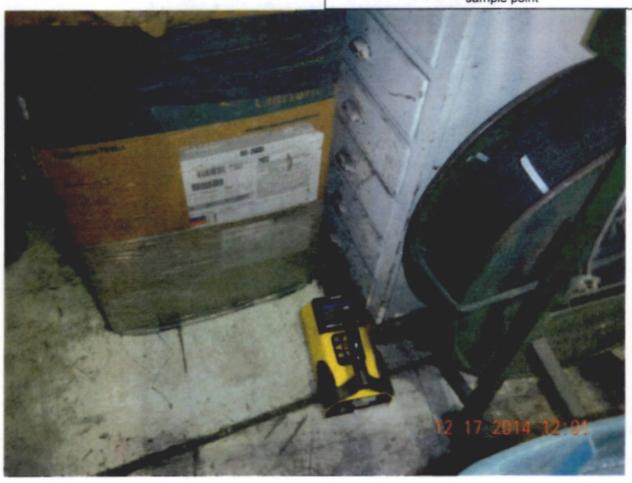
Area where mercury containing refrigerators were formerly located, NE corner building #1,

sample point

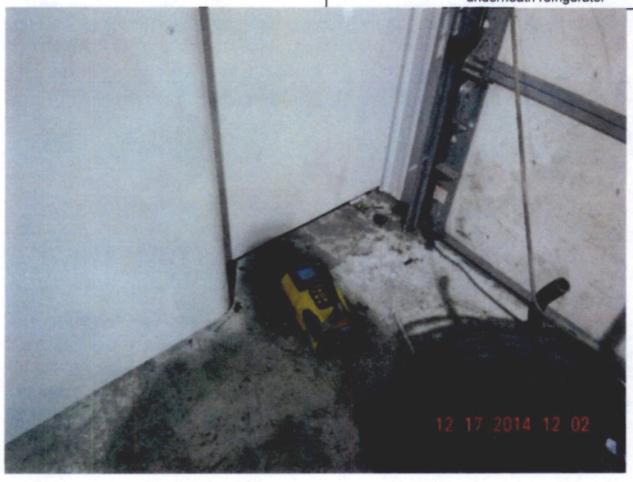
Mercury containing refrigerators, NE corner building #1, sample point #18

underneath refrigerator

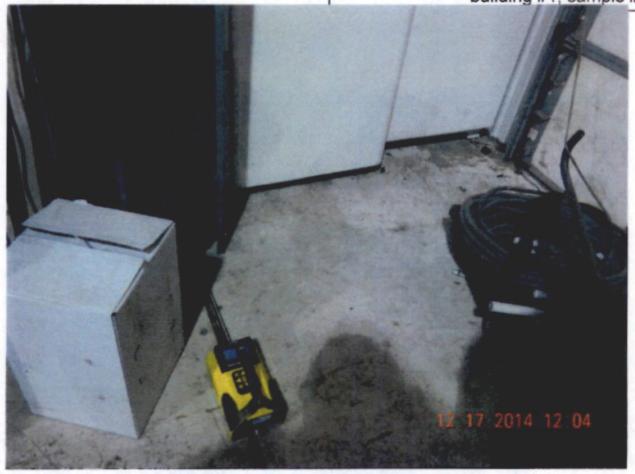
Crack sample point, NE corner

building #1, sample #19

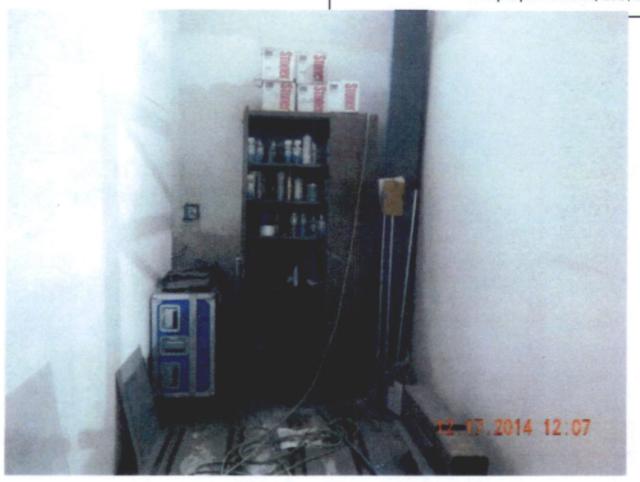
File cabinet, SE corner of building #1,

sample points #20A, 20B, #20C
